Date 07.12.01	Ref. No. TV04501R2	Model KD-28DX40U, KD-32DX40U, KV-28LS35B, KV-28LS35E, KV-28LS35U, KV-32LS35B, KV-32LS35E, KV-32LS35U	PC
Subject 28"/32" H-Out Service Kit [REVISION 2]			IRIS 1111

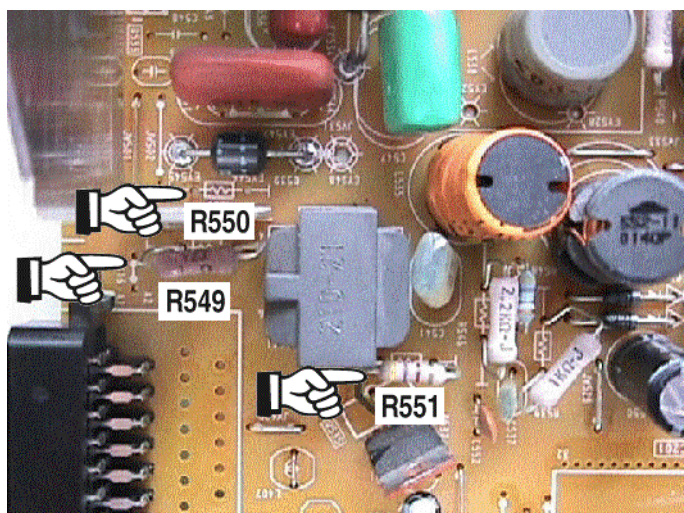
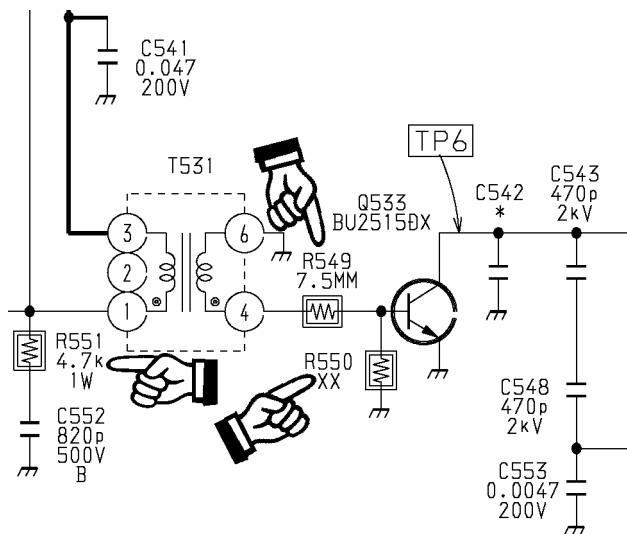
H-out failure (Q533).

High power/current surge.

On the A Board, install the "28"/32" H-Out Service Kit" (9-948-014-40) as outlined below.

- Replace **Q533** "BU2515DX-127" (8-729-049-08).
- Add **R550** "10 Ohm 2W" (1-215-880-00).
- Replace **R551** "4.7k" (1-215-873-00) with "2.2k 1W" (1-215-871-11).
- Replace **R549** "Jumper 7.5mm" (1-535-143-71) with "0.22 Ohm 2W" (1-216-361-00).
- Check whether C542 is mounted properly and that the anode cable is connected with the CRT properly.
